TRANSPORTATION SAFETY

REFLEXIONS

Issue 3 - July 2002

P I P E L I N E

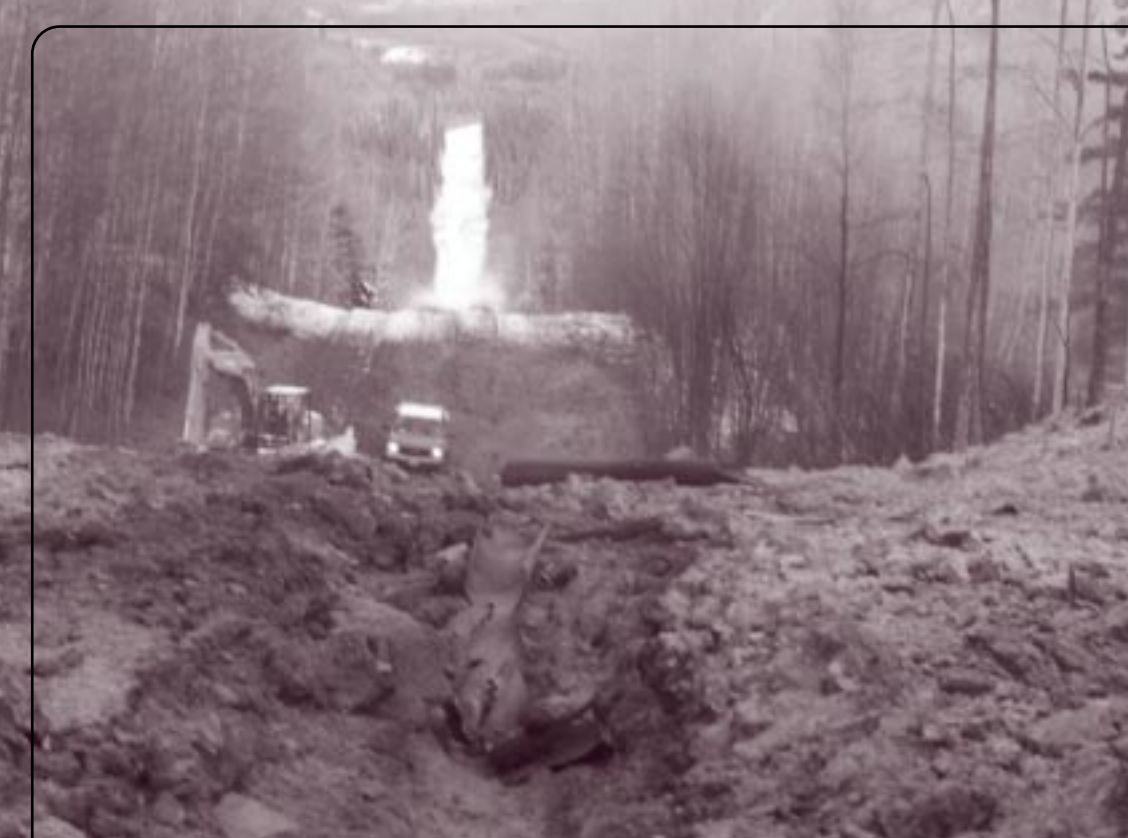
Subsequent to the December 1996 rupture, on 02 December 1997, the TCPL pipeline system experienced another rupture at an area of external corrosion, this time on Line 100-3 near Cabri, Saskatchewan. The pipeline ruptured as a result of localized wall thinning due to external corrosion which had occurred where the pipe coating had either been damaged or become disbonded. Between 68 and 72 per cent of the original wall thickness had been lost due to corrosion.

Ruptured pipe on Line 100-3 near Cabri, Saskatchewan.
